**RE: Additional Lead-Based Paint Testing and Confirmatory Paint Chip Sampling
Remington Rand – Building B (1st Floor)
180 Johnson Street
Middletown, Connecticut
Eagle Project No. 12-002.13**

LEAD-BASED PAINT INSPECTION
REMINGTON RAND UPGRADES
180 JOHNSON STREET
MIDDLETOWN, CONNECTICUT
LEAD-BASED PAINT XRF READING # DIAGRAM

SHEET NO.
FP-1

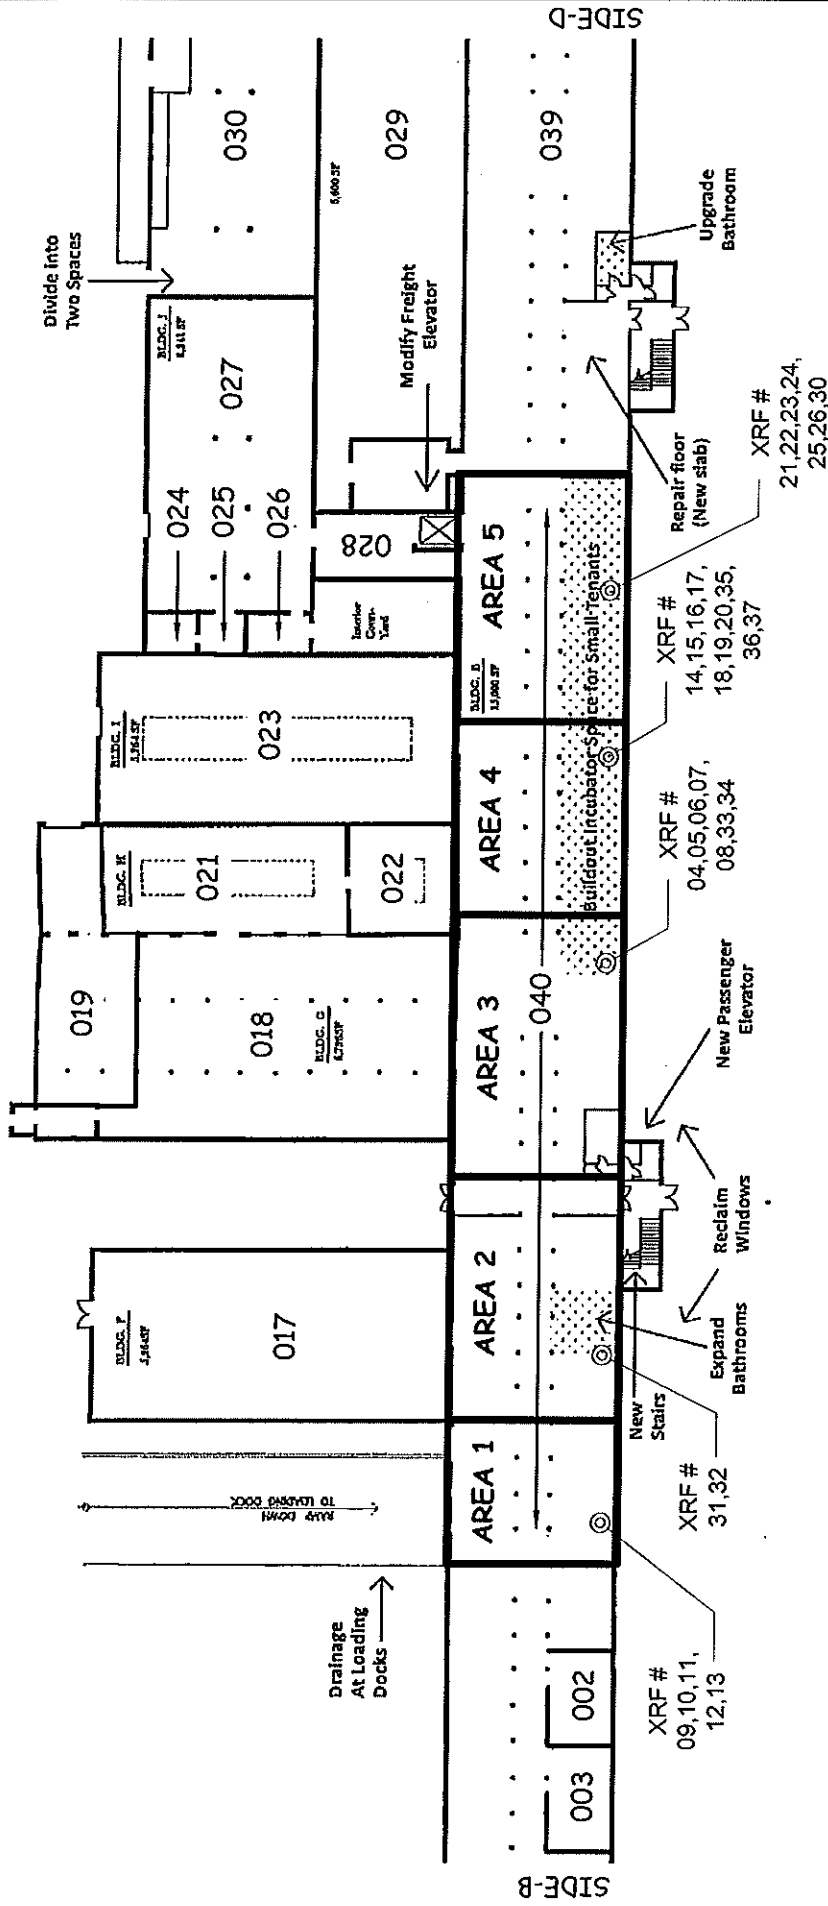
A total of forty (40) XRF readings were collected during the lead-based paint inspection within the first floor of Building B. There were fourteen (14) readings that were determined to contain high levels ($>1.0 \text{ mg/cm}^2$) of lead in paint. The structural wood columns and steel column brackets, wood window components, lower brick walls and sprinkler pipes were found to contain levels greater than 1.0 mg/cm^2 . These components that were confirmed to contain high levels of lead paint by way of XRF testing were identified throughout the inspected section of Building B. Additionally, the remaining tested structural components were determined to contain low levels of lead in paint. Although these levels of lead in paint were less than 1.0 mg/cm^2 , the contractor must perform an exposure assessment on employees during tasks when painted materials are disturbed.

PARTIAL FIRST FLOOR PLAN

Work associated with the metal sprinkler lines, lower brick walls, structural wood columns or metal column brackets that were confirmed to contain lead-based paint must be performed by lead trained workers. If the steel sprinkler pipes that were found to contain high levels of lead are to be replaced, the painted pipes may be recycled at an approved recycling facility. Paint chips generated during this work must be characterized for proper disposal.
